Safety Alert

Electrical Fire

Alert No: 03 / 2021

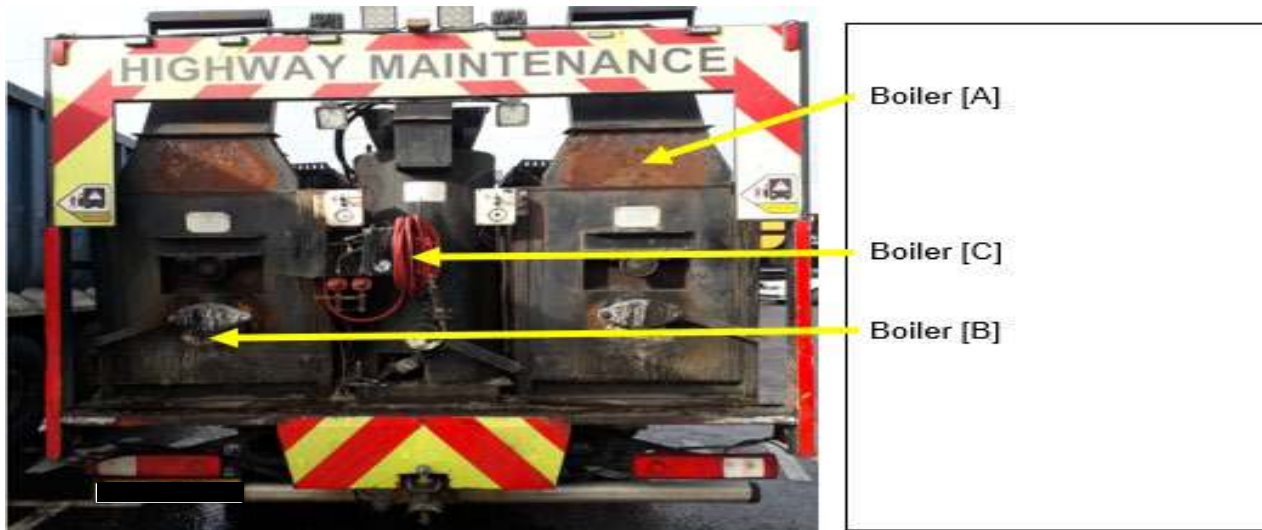
It had been decided to utilise down time on a wet day to switch a faulty/defective temperature sensor on boiler A with a similar type that was already fitted to boiler C to enhance productivity the next day.

After turning the isolation switch at the main battery, wires were disconnected of the sensors on boilers A and C. Whilst pulling through the wires from the control box housing, the wires began to spark and melt the protective insulation sheath to the cable loom. A fire extinguisher was swiftly discharged to reduce the possibility of a fire igniting and batteries were quickly disconnected.

Dia. 1 shows location of installed boiler to rear of vehicle.

Electrical 'Lock-out Tag-out' procedures & training were revisited, with direction given that only qualified auto electricians are to work on company vehicles. As best practice an isolator switch was installed for the renewed cable loom, and a 'check point' added to company procurement procedures ensuring such specialist fabricated plant will always require isolation controls as standard.

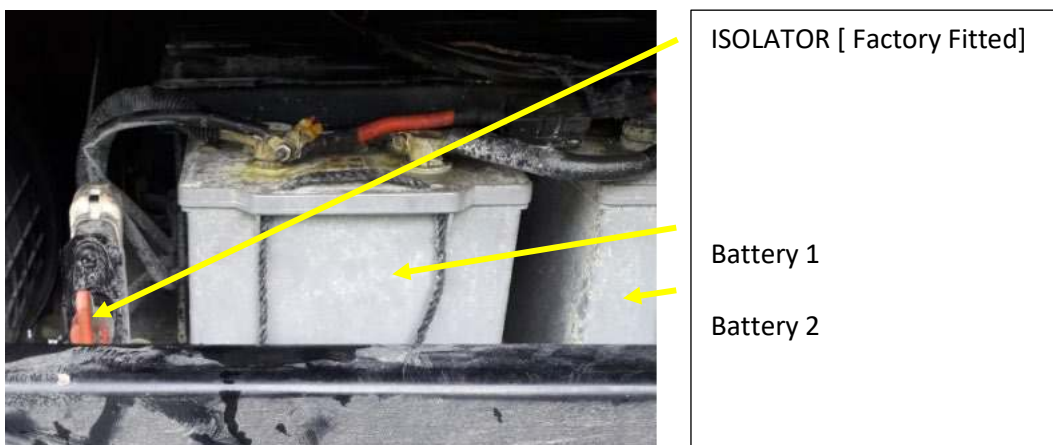
Batteries isolated at battery ... see Dia 2.

Persons performing the electrical alteration were not suitably qualified and did not follow Company Procedure fully regard 'lock-out tag-out', as a check by Multimeter was not performed to make sure electrical circuits were isolated. Assumption had been made that the isolator switch at the batteries controlled all rig circuits. The isolator switch was later proven to only cut power to the driving cab. Fuses were present at the control panel (loaded end) of the auxiliary system, but only by disconnecting the batteries would it have been possible to isolate the cable loom affected.
