# Safety alert

## Hot Box Incident - Safety Alert

Alert No. 1/2021 – January 2021

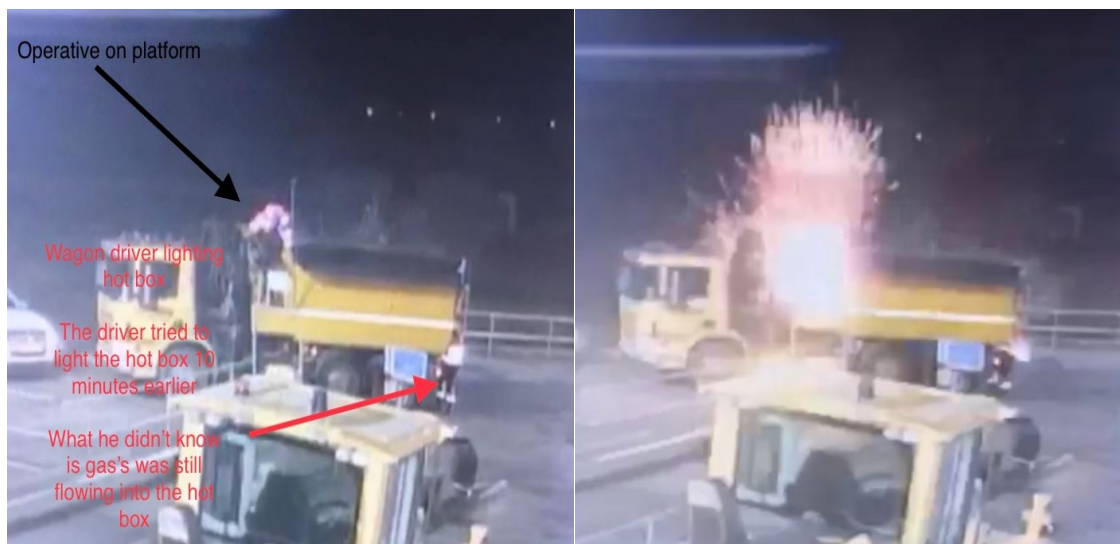
There was a time delay and the operative then attempted to re-ignite the heater system on hot box, what he did not realise is the gas had still been flowing into the hot box.

The ignition worked on this occasion and there was a build-up of gas inside the hot box.

This caused an explosion which you can see on the safety alert and the video.

**The operative was extremely lucky not to be seriously injured or killed, he was two seconds away from being blown off the hot box.**

- IS YOUR HOT BOX MAINTAINED TO MANUFACTURERS RECOMMENDATIONS?
- ARE THE PEOPLE TRAINED AND COMPETENT TO WORK ON THE EQUIPMENT?
- HAS ANY MODIFICATIONS / QUICK FIXES BEEN PUT IN PLACE TO GET IT WORKING?
- ARE YOU TRAINED TO OPERATE THE HOT BOX?

Failure to follow the above could cause life changing injury or death.
