Safety Alert

12/07/2021 - exploding airbag under the seat of the JCB 3CX Compact.

JCB 3CX COMPACT SEAT FAILURE

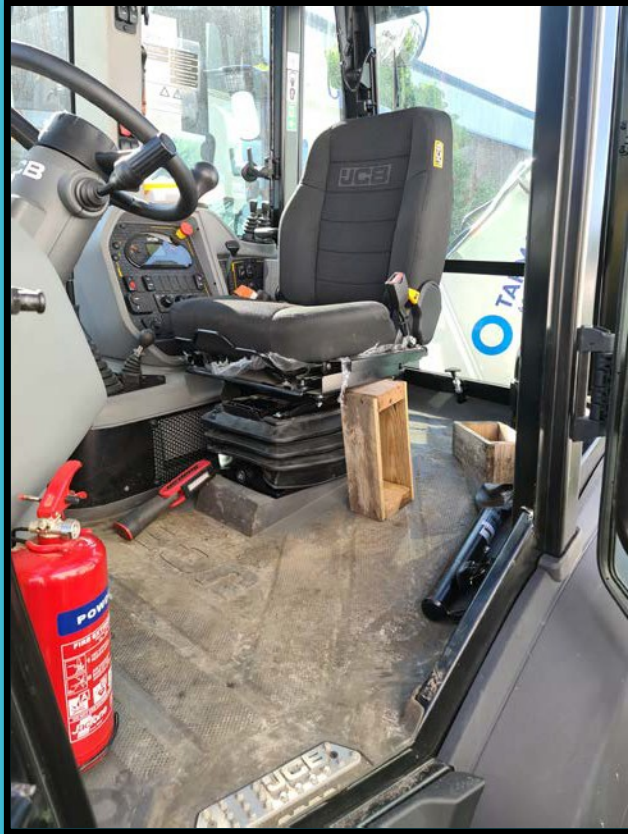
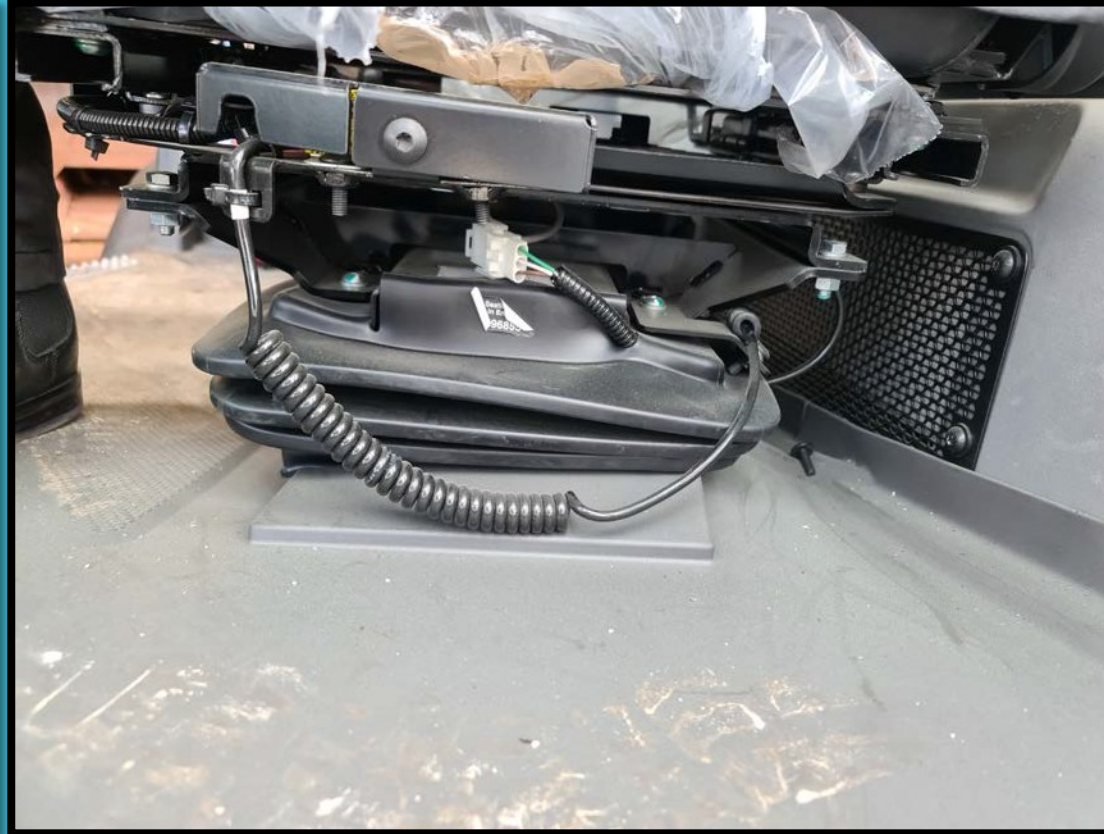
- First day being operated on site.
- Seat adjusted at the start of the shift.
- Was used for 3 hours prior to failure.
- Seat dropped approximately 11 inches.
- Video of seat dropping is not that fast, but is not under weight.
- Very loud bang which was heard by others on site.
- JCB attended site 2 days later, report outstanding.

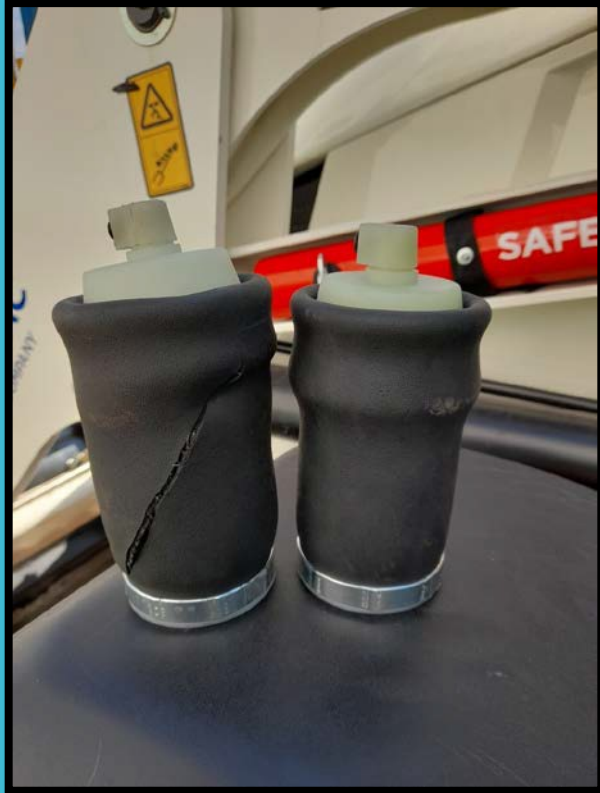
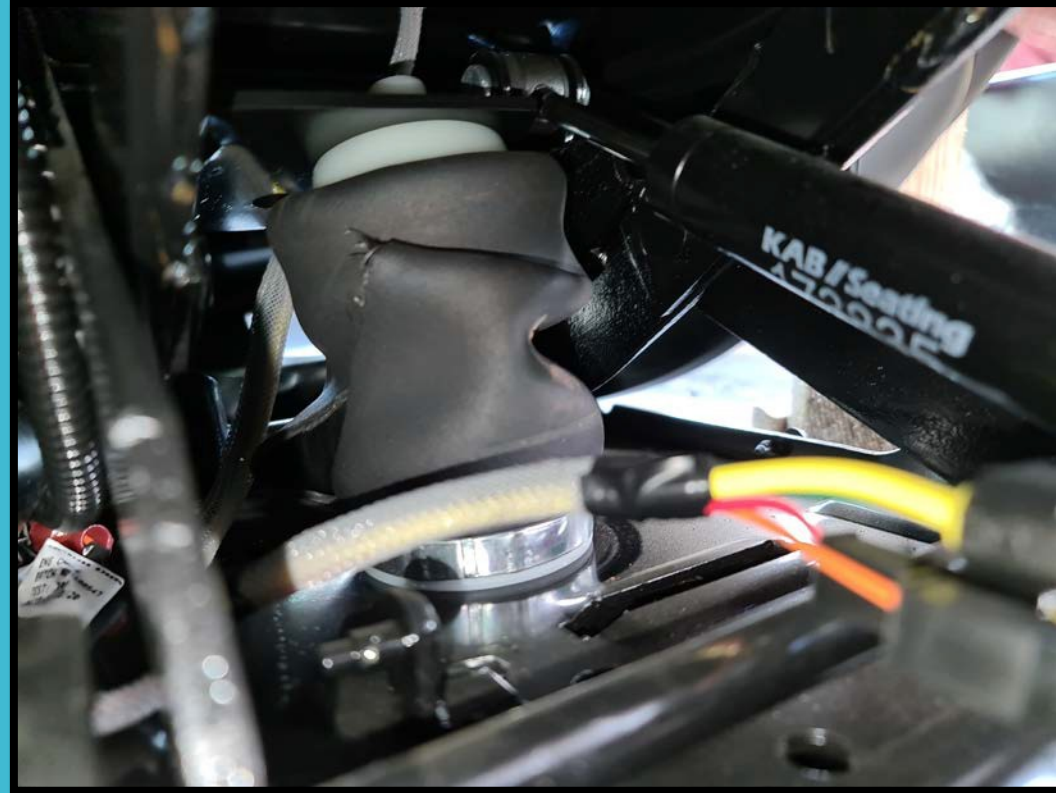
JCB 3CX COMPACT SEAT FAILURE

- Air bag has exploded under weight. The seat was adjusted 3 hours prior and operational.
- Failure happened when 3CX was stationary, with engine switched off (Which would switch off the compressor).
- Seat has a 'Comfort' alert which for a comfy ride needs to be green. Was likely red as operator stated he had fully inflated.

The Green/Red alert is for comfort in the operator's manual but until JCB find out why the airbag has exploded we should tell our operators to use it in the green only to ensure the air bag is not under too much pressure.
