Airport Taxiway Rehabilitation

Asphalt Reinforcement, Heathrow Airport, UK

Project Description

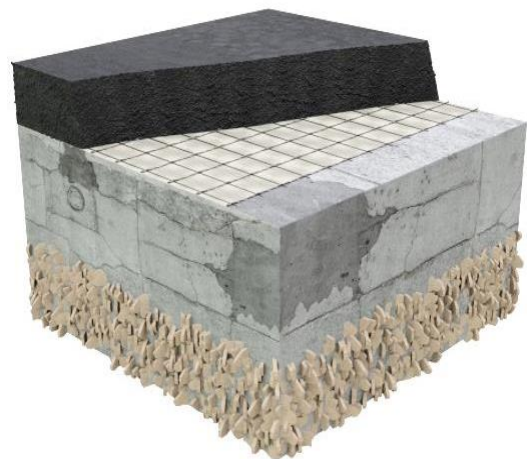
High-strength, low-strain reinforcement interlayer

The ABG range of asphalt reinforcement products provide a low strain composite layer combining a non-woven polyester geotextile and glass fibre or steel grid. Benefits include a substantial reduction in the asphalt overlay thickness required and a significant extension of the pavement service life, reducing associated maintenance periods and costs as a result.

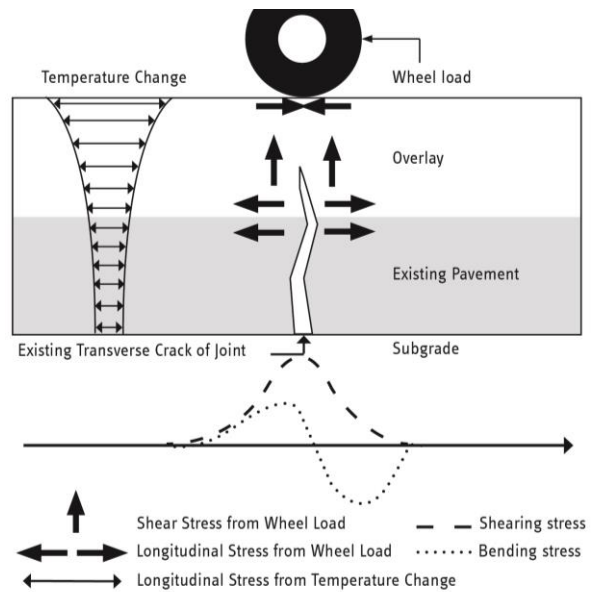
Mechanism of Reflective Cracking

The low tensile strength of asphalt means it can be easily damaged by a number of factors including settlement, fatigue, temperature fluctuations and impact loadings.

Damage arising from reflective cracking means increased maintenance disruption and costs. A cost-effective method for controlling reflective cracking and further deformation of the pavement was therefore required.

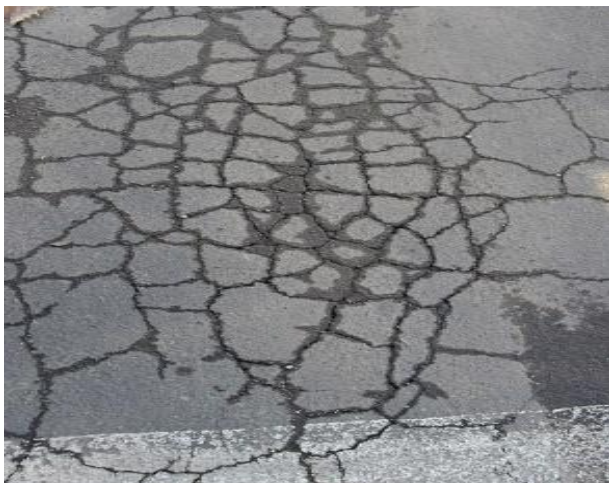
Solution to reflective cracking

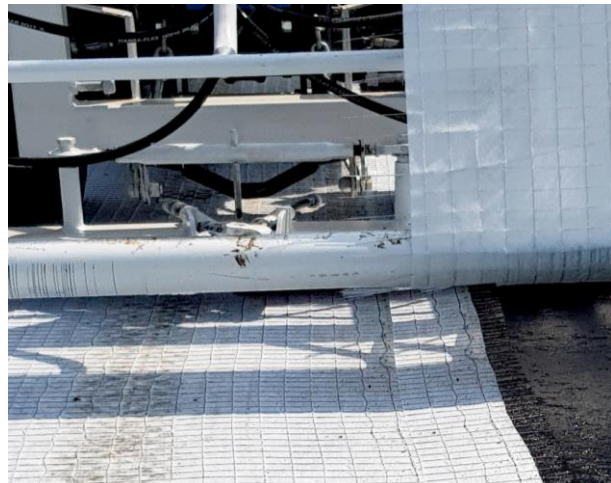
Quick to install and bond, with reduced overlay required

Following pre-patching and joint-sealing, 6,400 m² of asphalt reinforcement grid was supplied and installed by ABG Ltd on Taxiway Blocks 118/119. The ABG reinforcement layer was installed directly on the existing surface and immediately overlaid with a 50mm proprietary surfacing material. Disruption to air traffic was minimised by working under night-time closures over 2 shifts.
